Inspection Report

Wanzhi el

Inspector:	/
Inspection location:	Boxing County, Binzhou City, Shandong Province
Date of inspection:	/

SGS order No.:	IN-SC-5801-17003		
Coordinator:	/	Telephone:	/

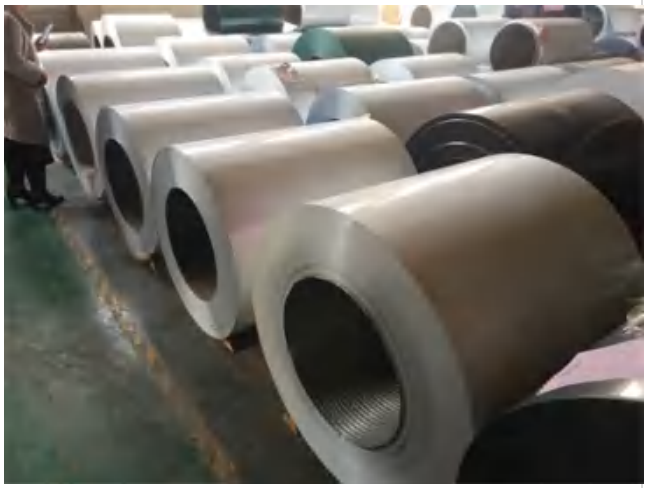
Fig.1 the coils at factory warehouse

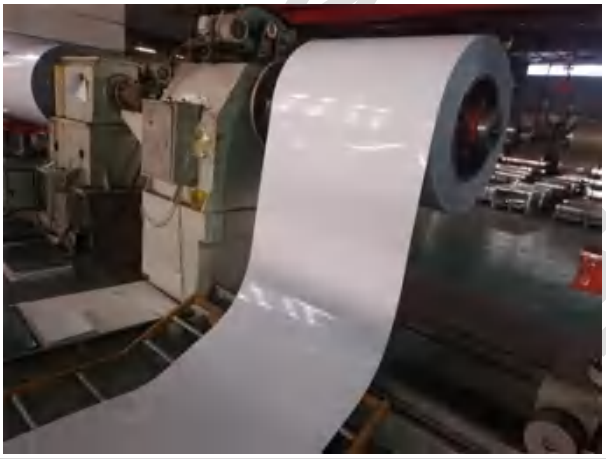
Fig.6 plates cutting in process

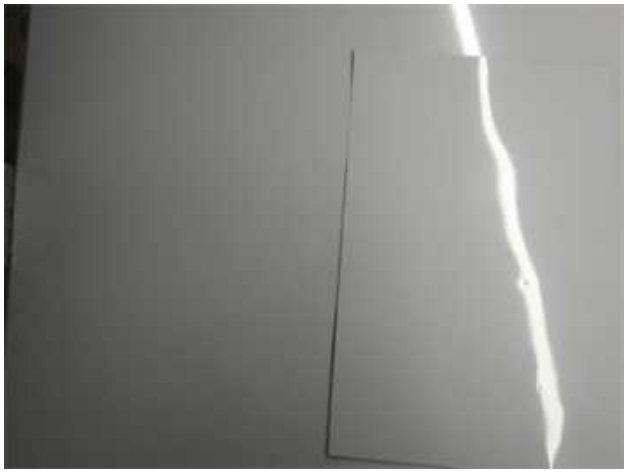
- → Total 300pcs cutting plates were choice for performed visual check
- → The surface of plate(the white face) was covered with plastic film
- → All of plate structure of surface was performed inspection, free of damaged, and no obvious defects (like that rust, scratches, blisters of lacquer etc.) was found, acceptance
- → The color check was conducted, and it is no different with color sample that provided by client, acceptance

Fig.23 plate color check with sample

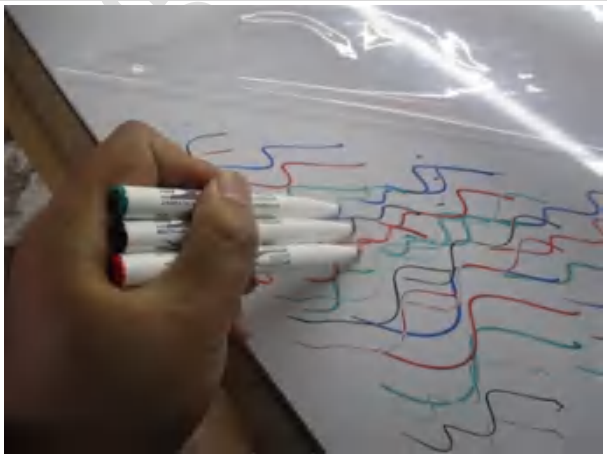
In this visit, SGS inspector was conducted marker removal test, for this test, the markers and eraser are provided by client, SGS inspector drew on the plate with three color markers, and then removal them by used eraser, it is easy to wipe off, and no any color was found on the plate, acceptance

Fig.33 marker removal test witness

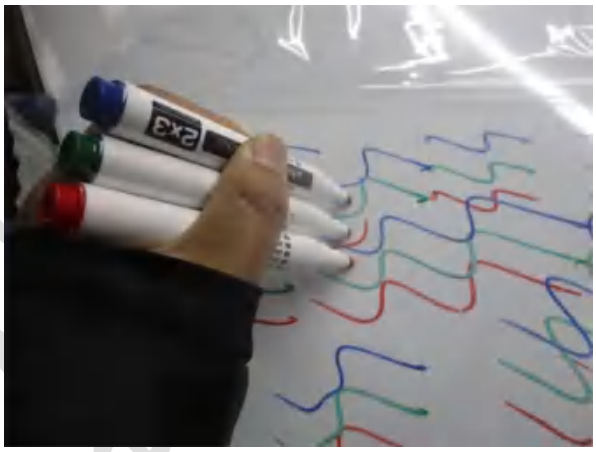
Fig.37 marker removal test witness

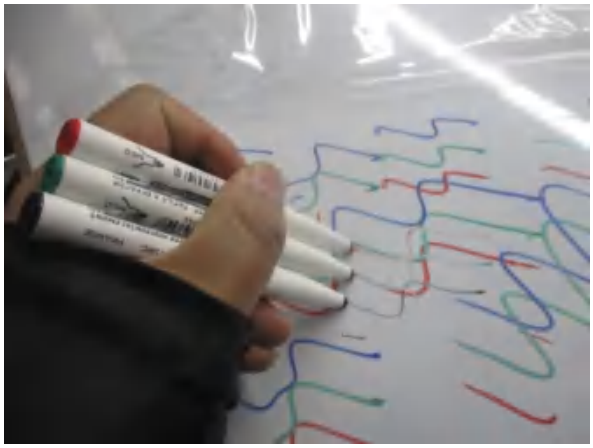
Fig.38 marker removal test witness

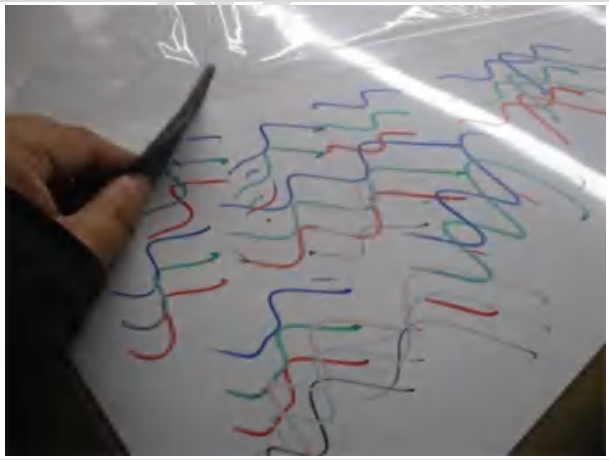
Fig.39 marker removal test witness

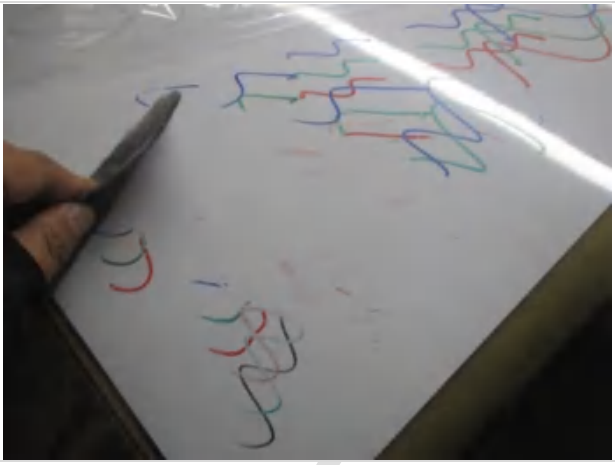
Fig.40 marker removal test witness
