INSPECTION REPORT

APPLICANT: ZHENGZHOU WANZHI STEEL MATERIALS CO., LTD

INSPECTION DATE: Mar 24, 2026

COMMODITY DESCRIPTION: PPGI (NOT EMBOSSED)

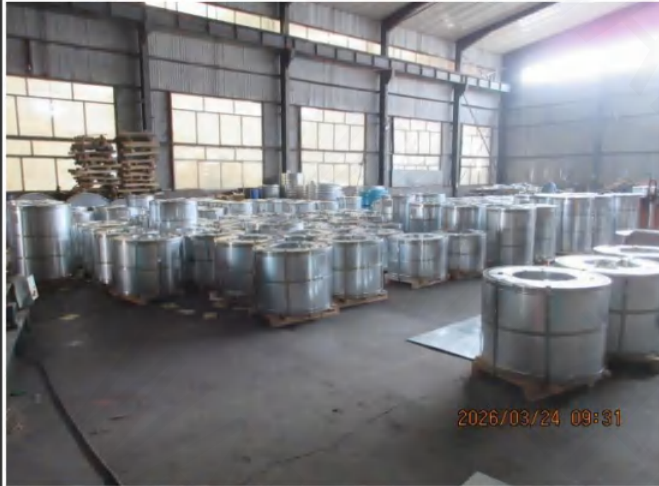
Pic.1 General picture of goods

Description	Size (Declared)	Color	Quantity
PPGI (NOT EMBOSSED)	0.45*613 MM	RAL9003	24 Coils
	0.45*673 MM	RAL9003	14 Coils
	0.45*730 MM	RAL9003	47 Coils
	0.45*810 MM	RAL9003	41 Coils
	0.45*1145 MM	RAL9003	16 Coils
	0.8*1000 MM	RAL9003	8 Coils
TOTAL			150 Coils

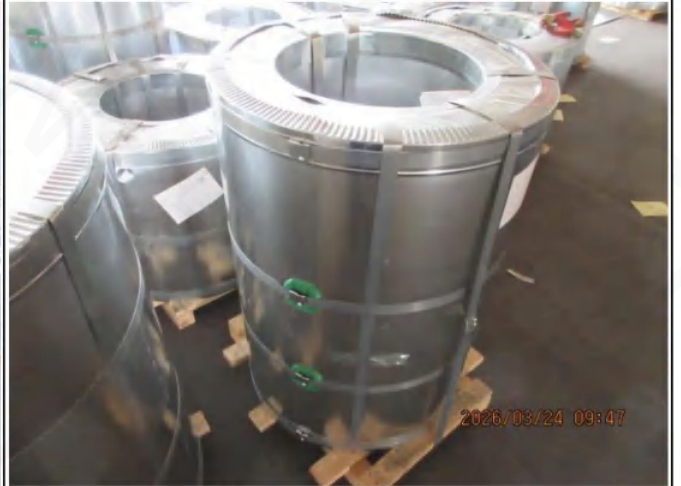
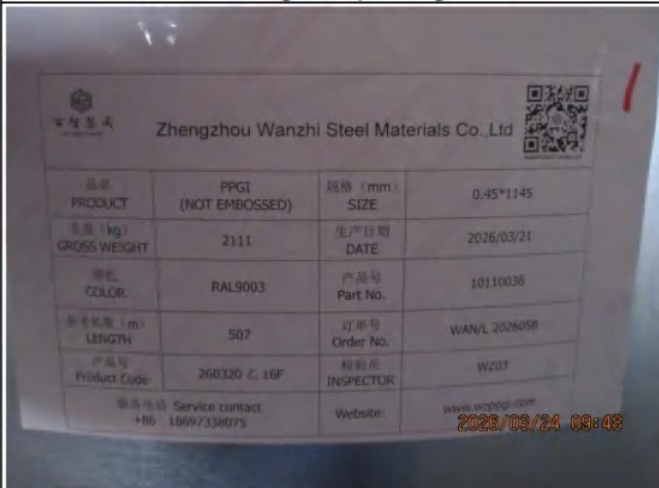
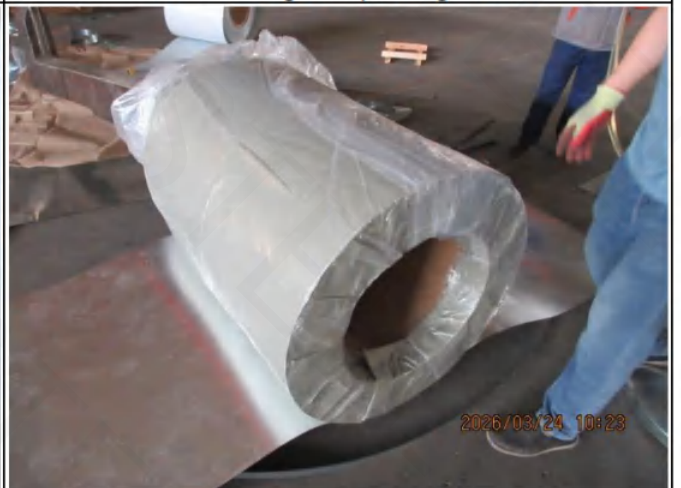
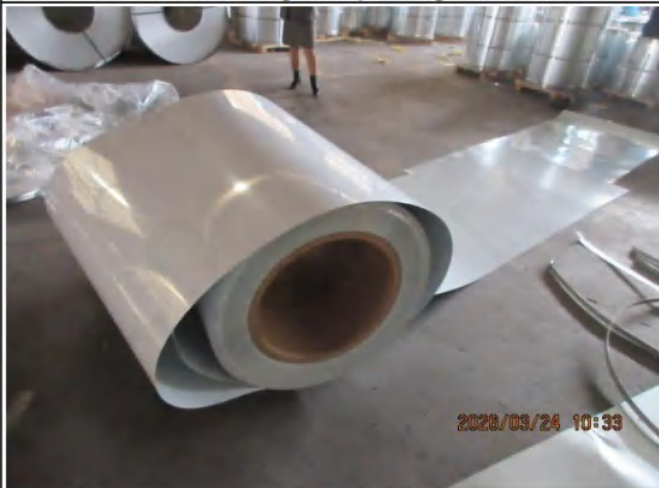
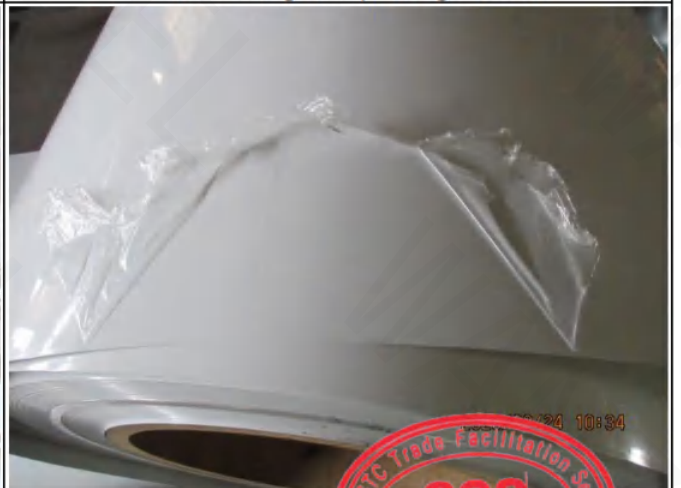
Pic.2 Marking and package check

Marking: Two paper labels were found on each shipment package.

- a) Cargo was packed with galvanized steel sheet. The inner packing was waterproof paper and plastic film.
- b) The goods were packed vertically and fixed on pallets. The surface of the goods was covered with plastic film.

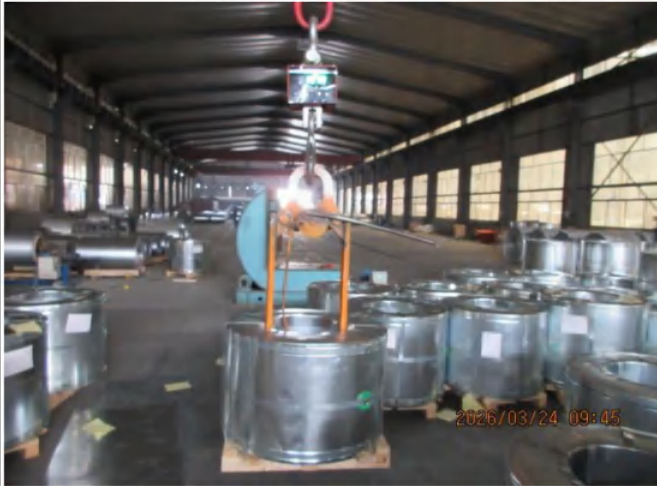
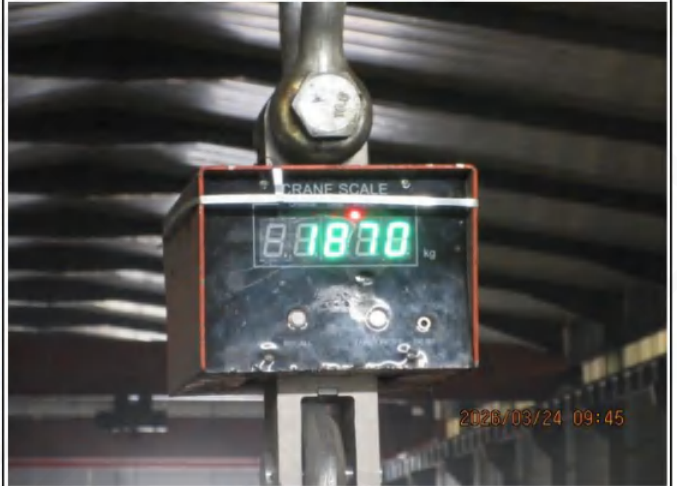
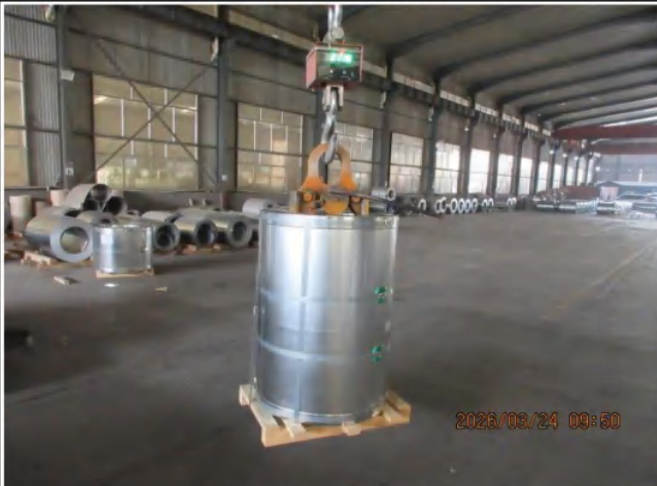
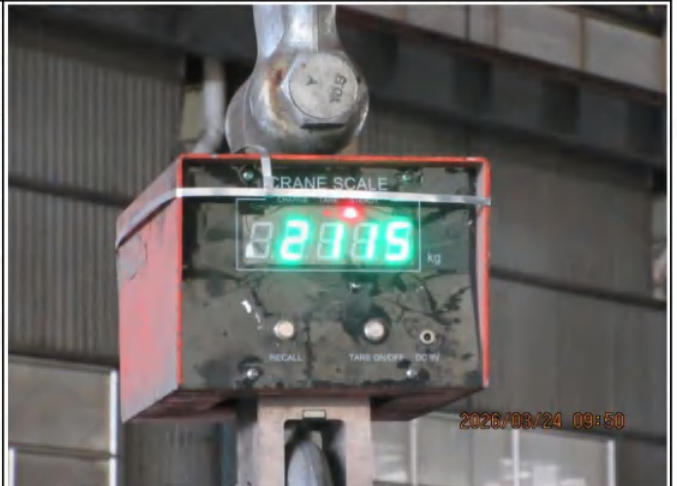
Pic.7 Weight check

Inspector randomly selected 2 coils from all coils to check the weight, the records were as below:

Size (Declared)	Color	Coil No.:	G.W. (Kgs) (Declared)	G.W. (Kgs) (Actual)
0.45*613 MM	RAL9003	260321 乙 20C	1871 KG	1870 KG
0.45*1145 MM	RAL9003	260320 乙 16F	2111 KG	2115 KG

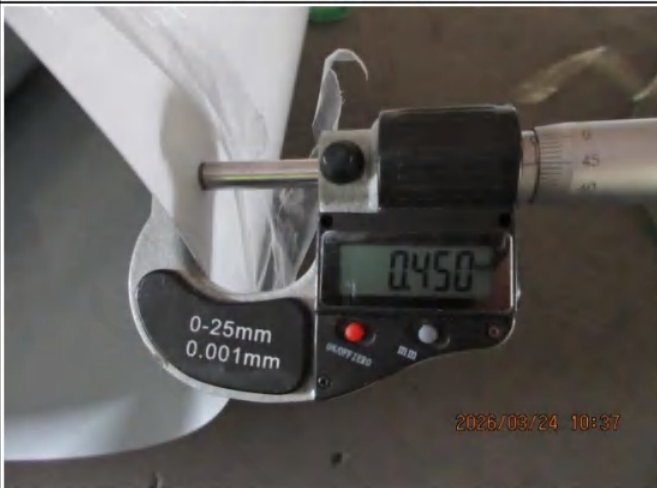
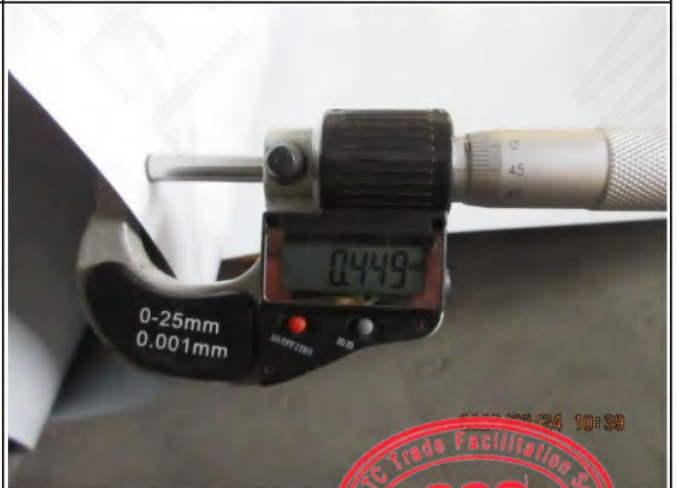
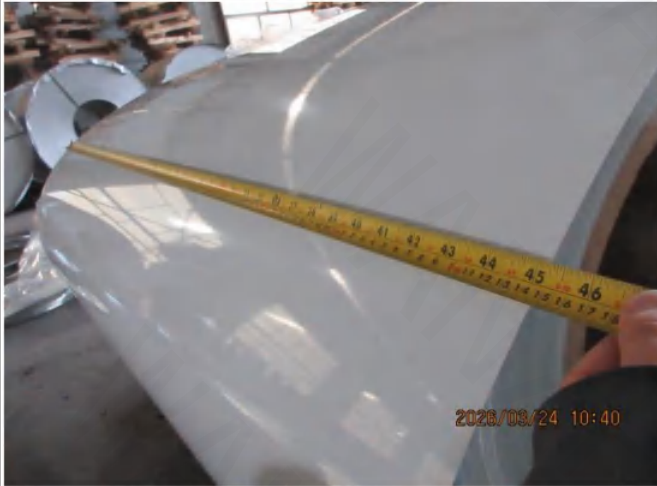
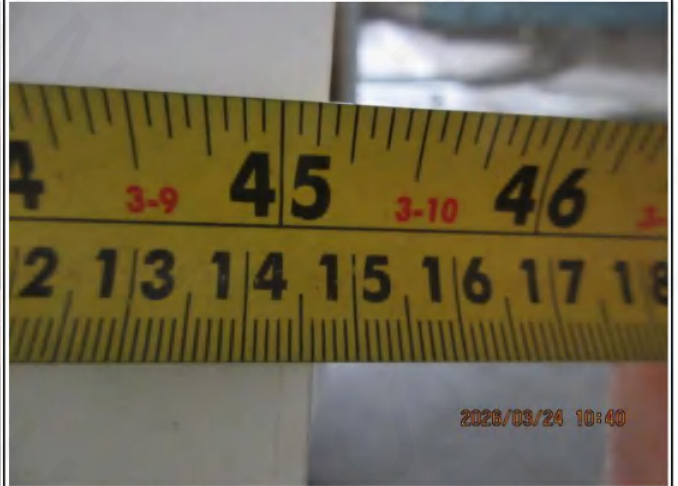
Pic.11 Dimension check

Inspector randomly selected 2 coils from all coils to measure the width and thickness, the records were as below:

Size (Declared)	Color	Coil No.:	Size (Actual)
0.45*613 MM	RAL9003	260321 乙 20C	0.448*613.0 MM
			0.452*613.0 MM
			0.451*613.0 MM
0.45*1145 MM	RAL9003	260320 乙 16F	0.450*1146.0 MM
			0.453*1146.0 MM
			0.449*1146.0 MM

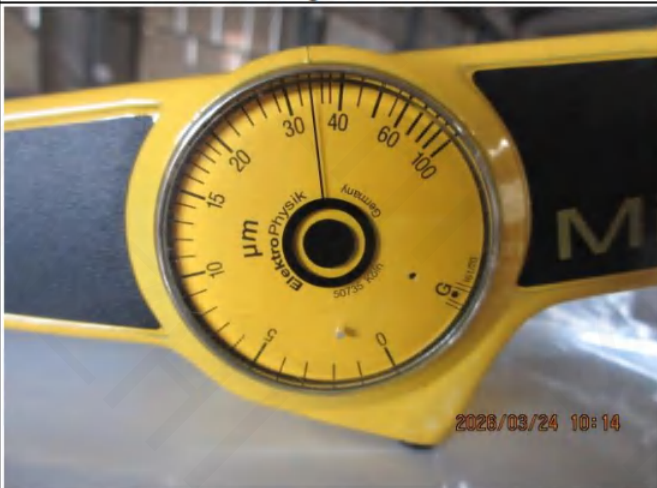
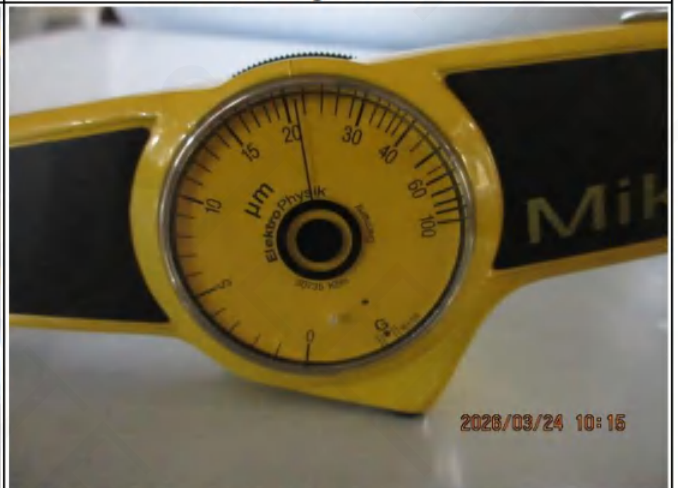
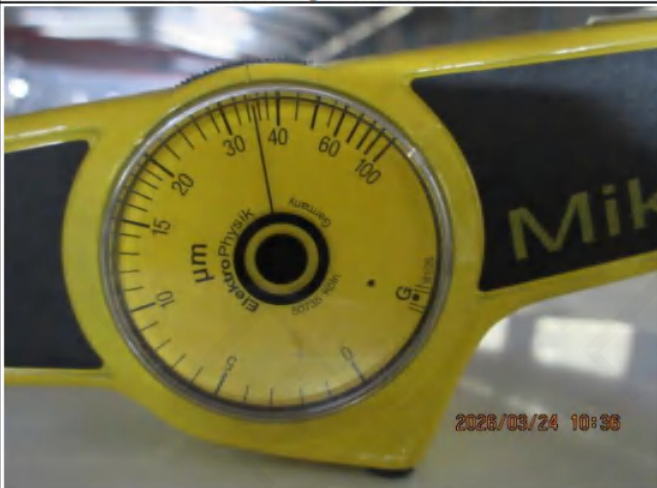
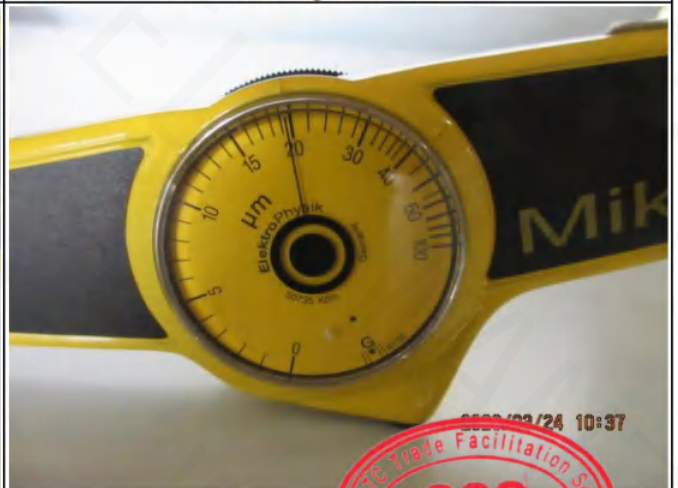
Pic.15 Coating thickness check

Inspector randomly selected 2 coils from all coils to witness the testing of coating thickness. The inspector of the factory conducted coating thickness by mechanical magnetic coating thickness gauge.

Item(mm)	Color	Coil NO.	Coating Thickness (µm) (Top Painting/Back)
0.45*613 MM	RAL9003	260321 乙 20C	34.0/21.0
0.45*1145 MM	RAL9003	260320 乙 16F	35.0/19.5

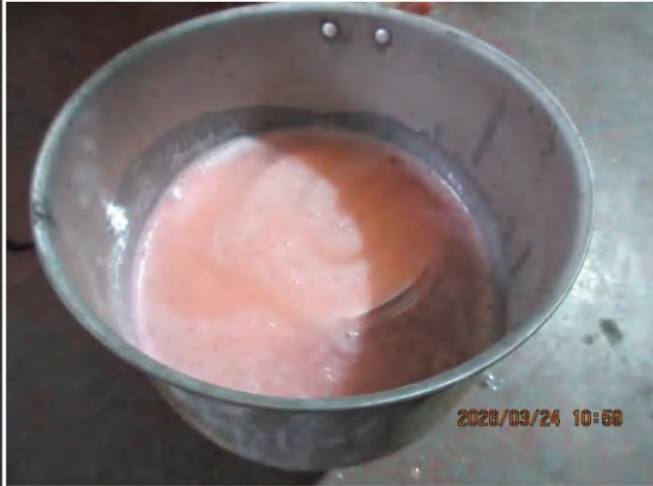
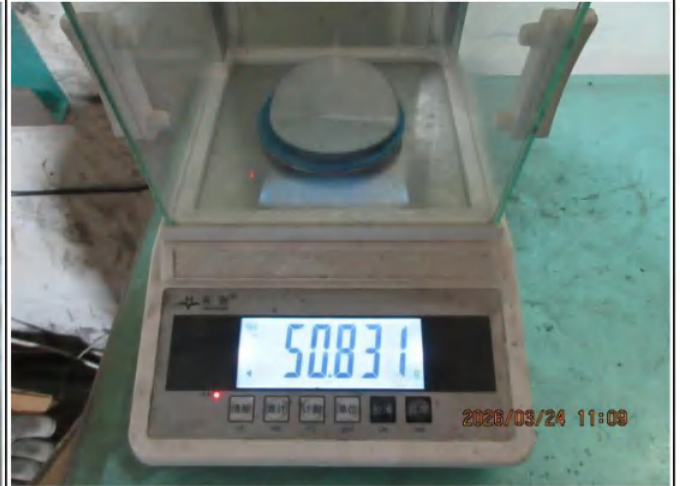
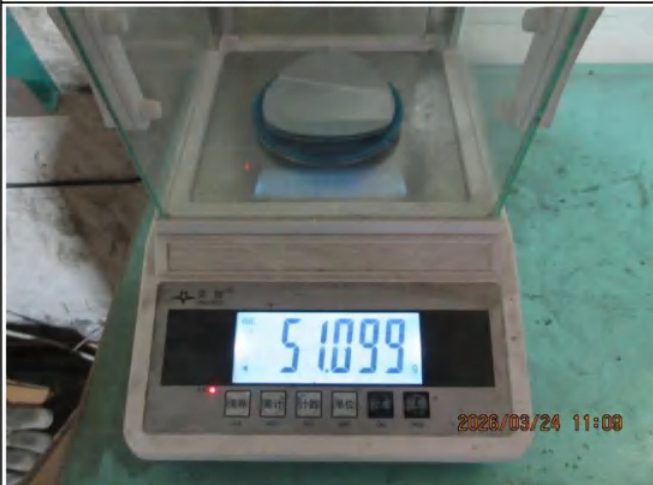
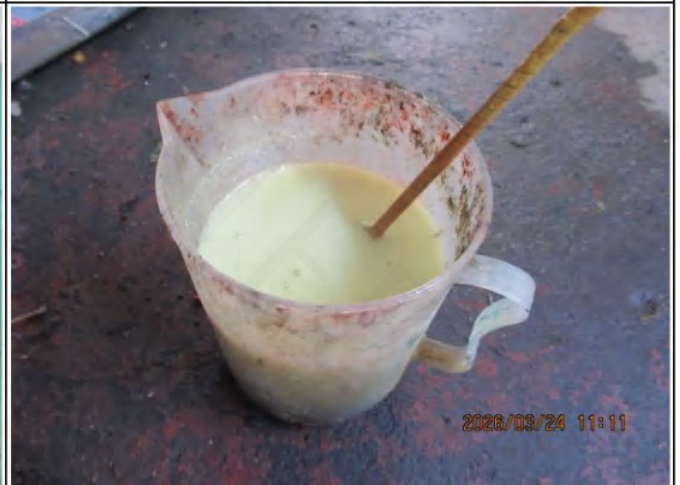
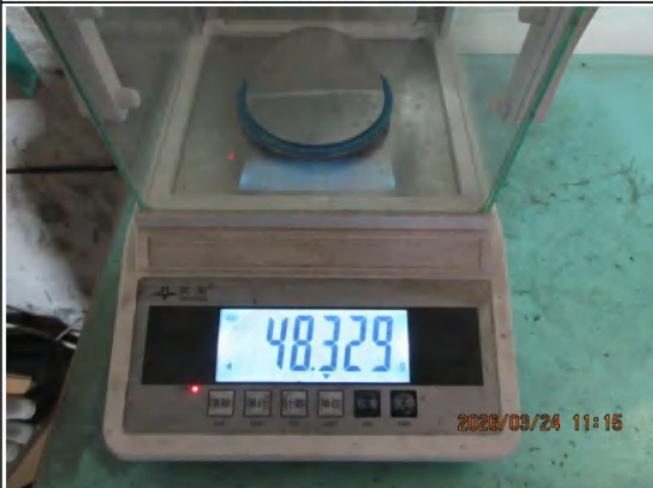
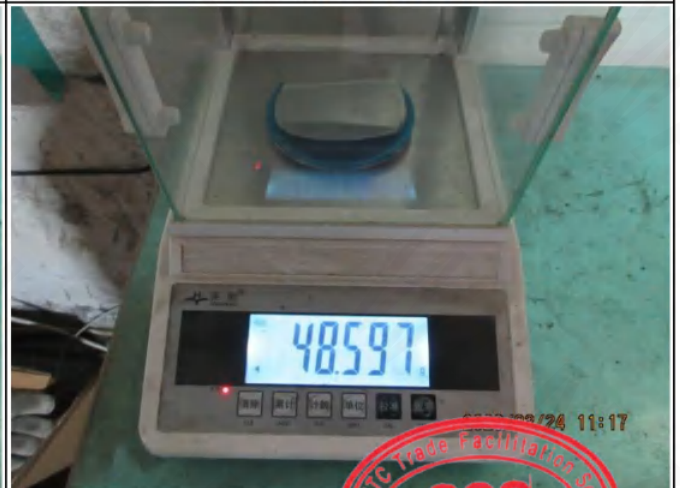
Pic.19 Zinc mass check

Inspector randomly cut 3 samples and witnessed the testing of zinc coating.

The inspector of the factory conducted Zinc coating testing by dissolved weighting method in the factory laboratory. The test results were as follows:

Size (Declared)	Sample area (m2) (A) (3pcs)	Weight before pickling (g)(B)	Weight after Pickling (g)(C)	Zinc coating (GSM)	Computational formula
0.45*613 MM	0.015072	50.831	48.329	166.00	(B-C)/A
0.45*1145 MM	0.015072	51.099	48.597	166.00	(B-C)/A
