## INSPECTION REPORT

**APPLICANT:** ZHENGZHOU WANZHI STEEL MATERIALS CO., LTD

**COMMODITY DESCRIPTION:** PPGI & GALVANIZED STEEL COIL

SGS-CSTC Standards Technical Services Co., Ltd  
TIANJIN China

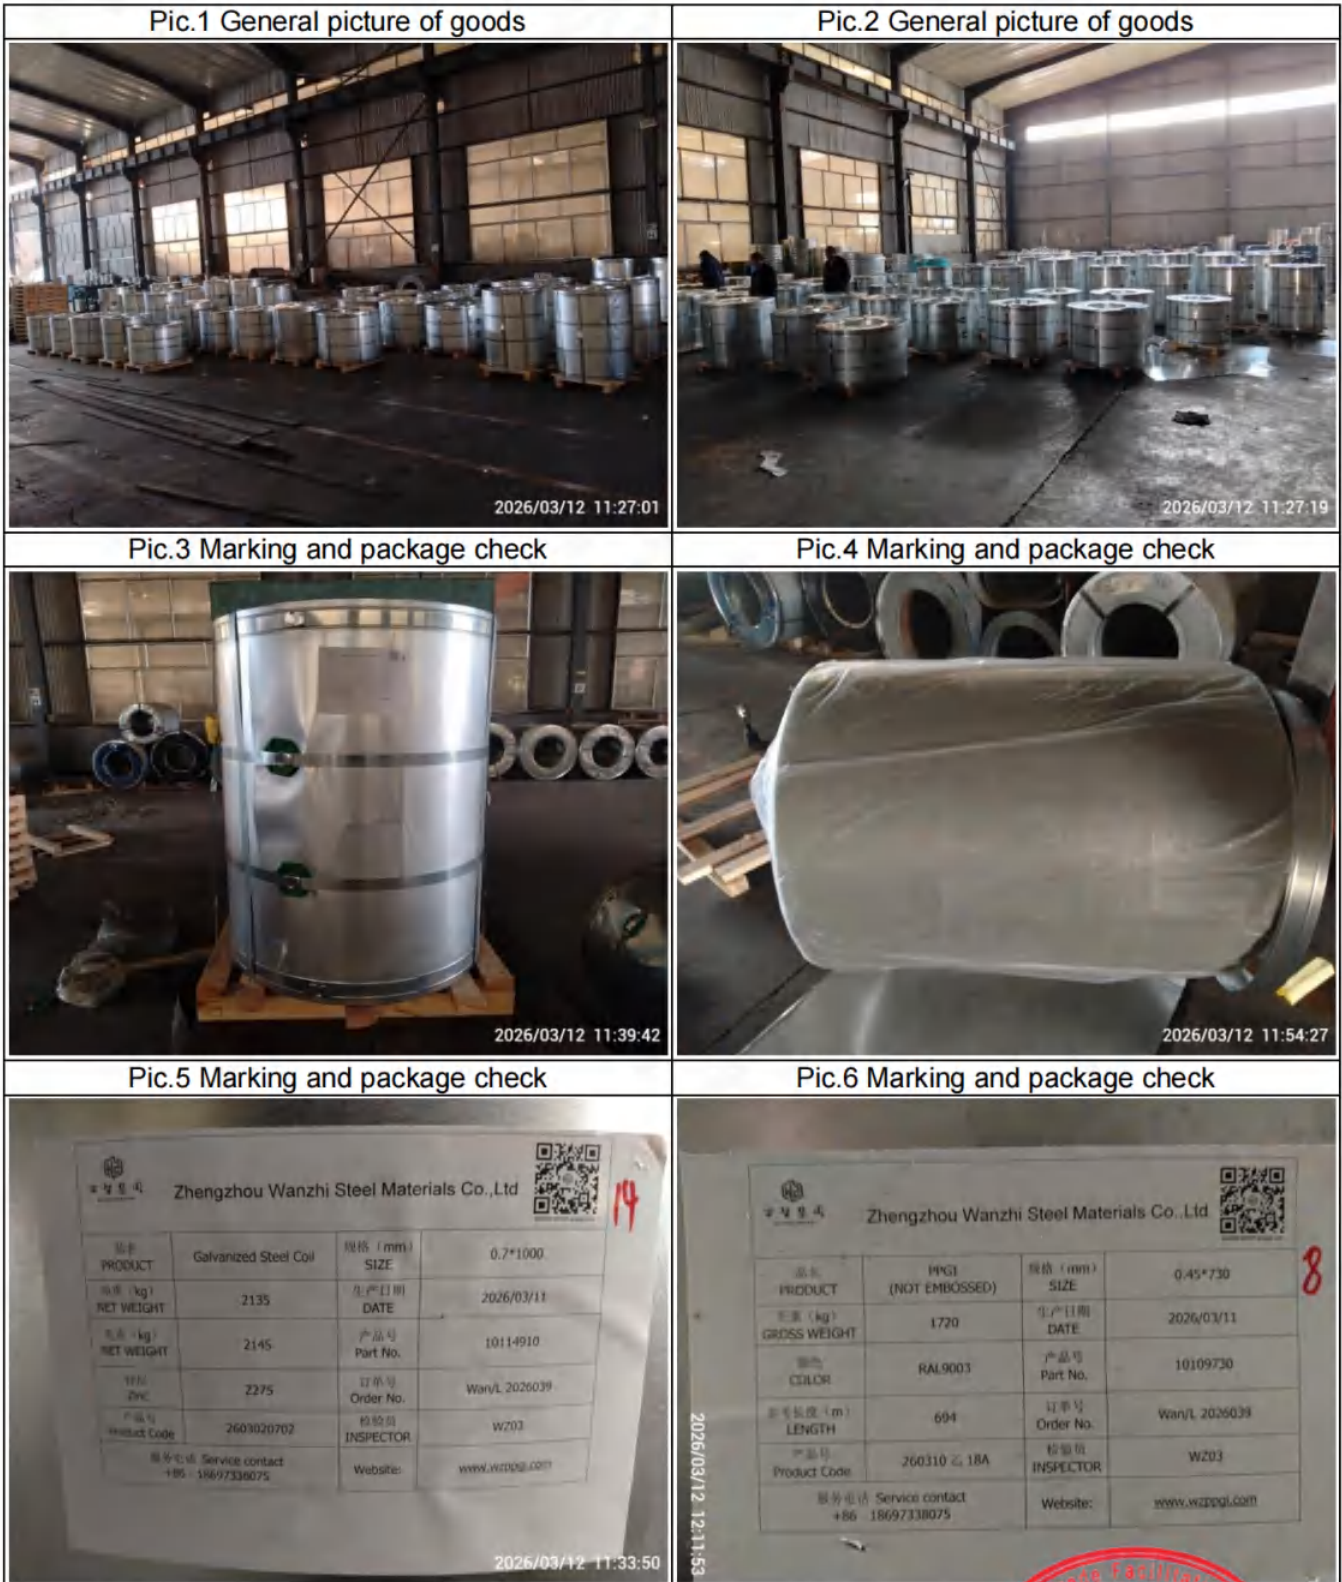
Marking: Two paper labels were found on each shipment package.

Zhengzhou Wanzhi Steel Materials Co., Ltd			
品名 PRODUCT	Galvanized Steel Coil	规格 (mm) SIZE	0.7*1000
净重 (kg) NET WEIGHT	2135	生产日期 DATE	2026/03/11
毛重 (kg) NET WEIGHT	2145	产品号 Part No.	10114910
材质 ZINC	Z275	订单号 Order No.	Wan/L 2026039
产品号 Product Code	2603020702	检验员 INSPECTOR	W203
服务热线 Service contact +86 18697338075		Website: www.wzppgl.com

Zhengzhou Wanzhi Steel Materials Co., Ltd			
品名 PRODUCT	MPGI (NOT EMBOSSED)	规格 (mm) SIZE	0.45*730
毛重 (kg) GROSS WEIGHT	1720	生产日期 DATE	2026/03/11
颜色 COLOR	RAL9003	产品号 Part No.	10109730
总长度 (m) LENGTH	694	订单号 Order No.	Wan/L 2026039
产品号 Product Code	260310 18A	检验员 INSPECTOR	W203
服务热线 Service contact +86 18697338075		Website: www.wzppgl.com

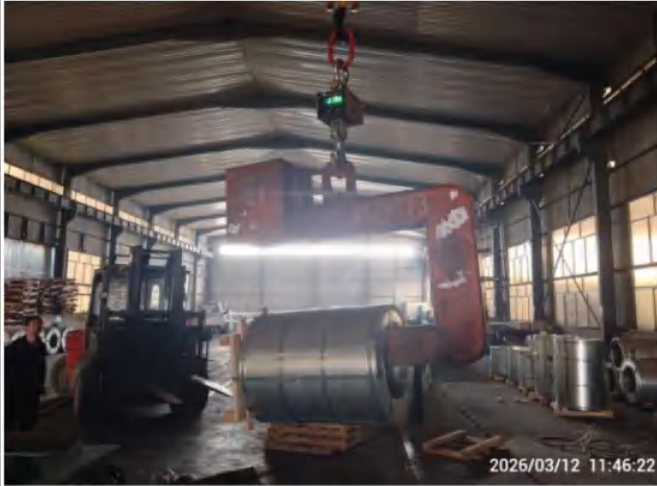
Pic.7 Weight check

Inspector randomly selected 2 coils from all coils to check the gross weight, the records were as below:

Size (Declared)	Color	Coil No.:	G.W. (Kgs) (Declared)	G.W. (Kgs) (Actual)
0.7*1000 MM	/	2603020702	2145 KG	2140 KG
0.45*730 MM	RAL9003	260310 乙 18A	1720 KG	1720 KG

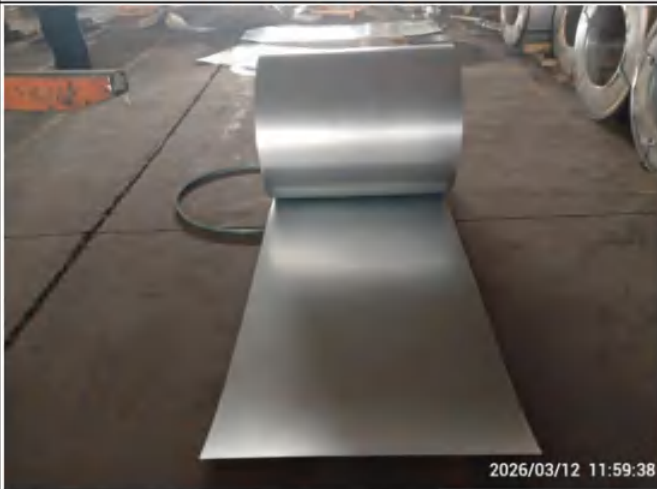
Pic.11 Dimension check

Inspector randomly selected 2 coils from all coils to measure the width and thickness, the records were as below:

Size (Declared)	Color	Coil No.:	Size (Actual)
0.7*1000 MM	/	2603020702	0.680*1000.0 MM
			0.688*1000.0 MM
			0.682*1000.0 MM
0.45*730 MM	RAL9003	260310 乙 18A	0.445*730.0 MM
			0.451*730.0 MM
			0.448*730.0 MM

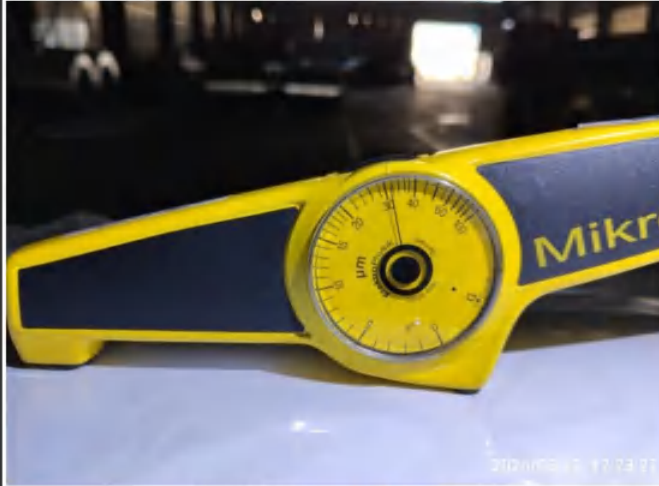
Pic.19 Witness of testing

Inspector randomly selected 1 coil from all PPGI and witnessed the testing of coating thickness. The inspector of the factory conducted coating thickness by mechanical magnetic coating thickness gauge.

Size (Declared)	Color	Coil NO.	Coating Thickness (µm) (Top Painting/Back) (Actual)
0.45*730 MM	RAL9003	260310 乙 18A	31.0 / 18.0

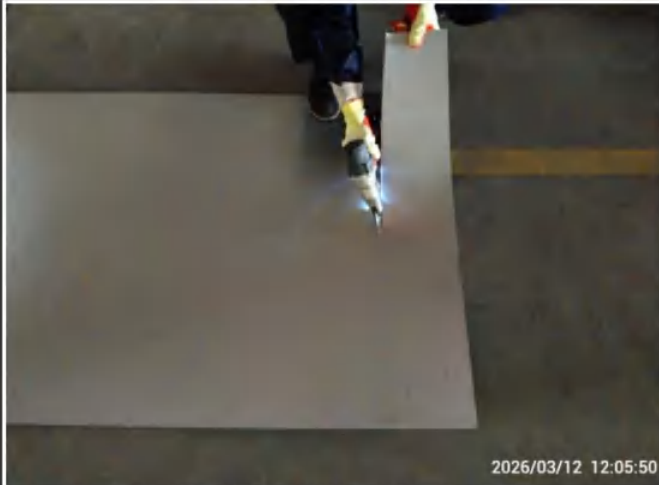
Pic.21 Witness of testing

Inspector randomly cut 3 samples and witnessed the testing of Zinc coating.

The inspector of the factory conducted Zinc coating testing by dissolved weighting method in the factory laboratory. The test results were as follows:

Item(mm)	Coil No.:	Sample area (m2)(A) (3pcs)	Weight before pickling (g)(B)	Weight after Pickling (g)(C)	Zinc coating (GSM)	Computational formula
0.7*1000 MM	2603020702	0.015072	80.063	75.541	300.02	(B-C)/A
0.45*730 MM	260310 乙 18A	0.015072	50.206	47.776	161.22	(B-C)/A
